8608 Service Bulletin.

Steel hydraulic lines for cut off cylinders.

8/8/2024

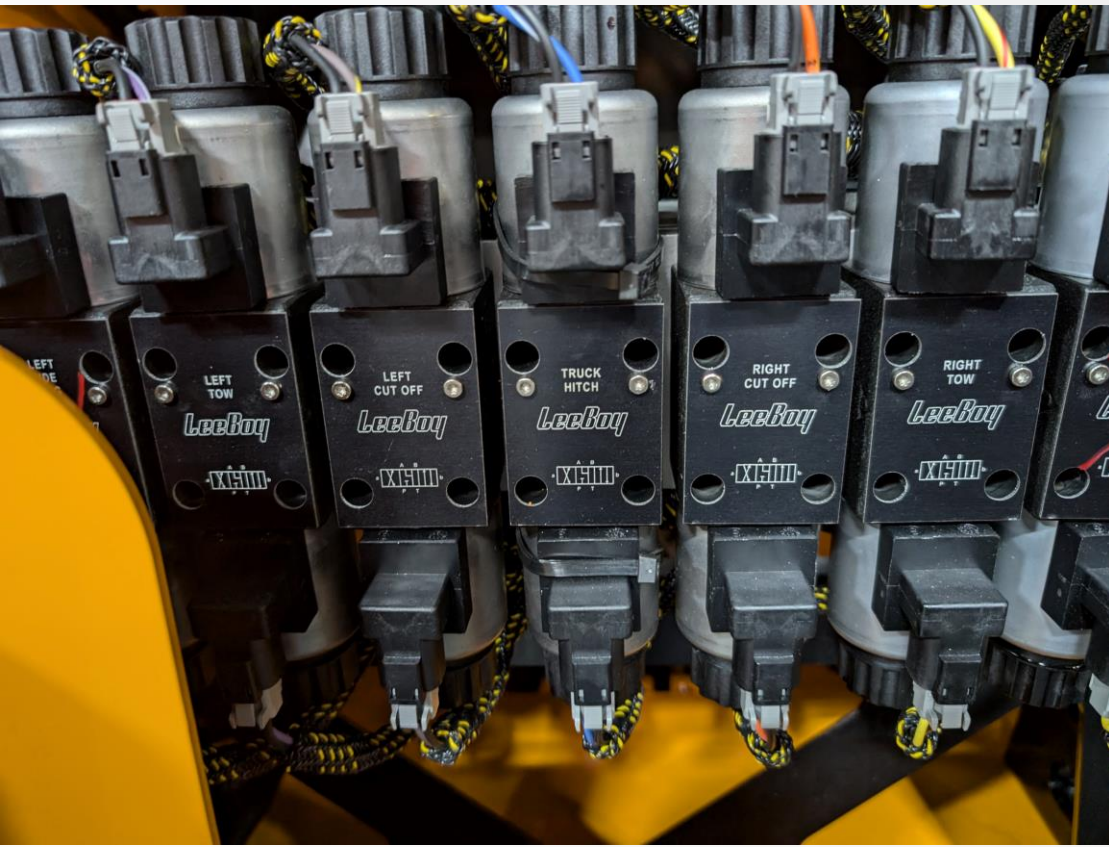
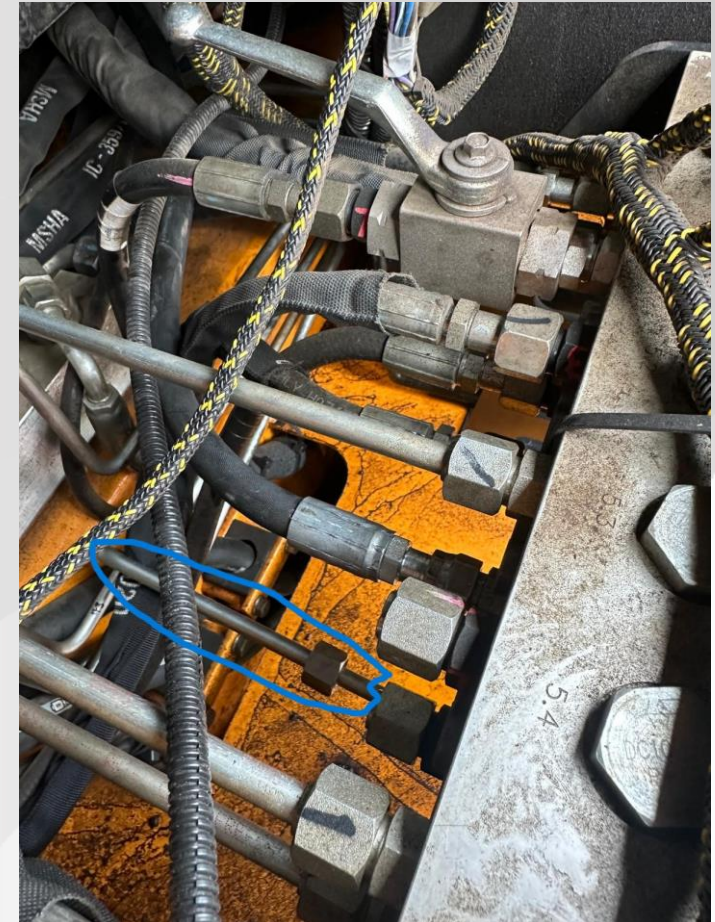
Located inside the left side engine access door.

Steel lines behind the left and right cutoff cylinder valves.

All 8608 machines with a serial number between 401045 and 451290. When performing next maintenance should be inspected for steel line and replaced with hoses.

Please order 1 kit per unit # 1030184 thru parts .

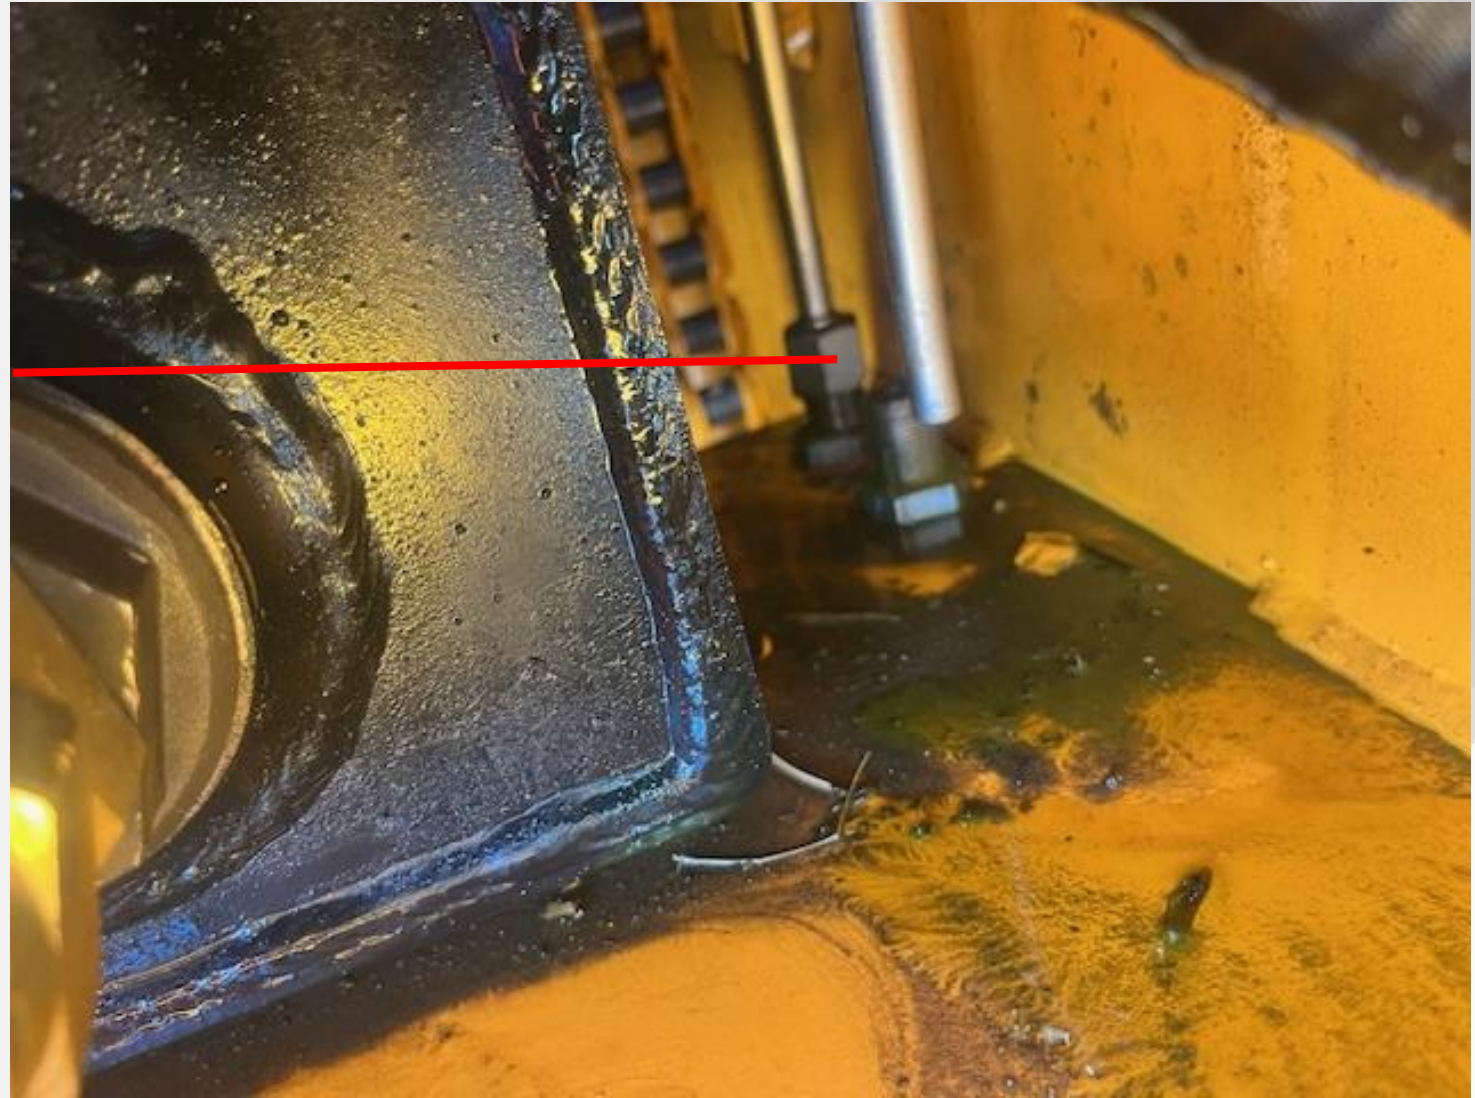
Inside the right and left engine access doors, Cutoff cylinder line bulkheads are located between tank and frame.

Use ratchet and a couple of extensions with a 21mm crow foot to remove the lines.

This will take 2 people to line the crow foot and Turn the nut to remove it.

Cut them, pull them out to discard.
